ROOFING CASE STUDY

Bayne-Jones Army Community Hospital's SPF Roof Holds Firm in 180 mph Hurricane

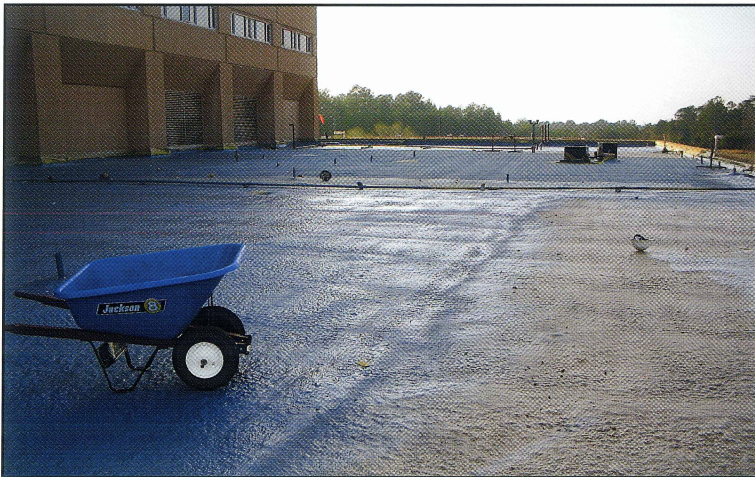
While Hurricane Katrina was not a factor for the Fort Polk Base, Hurricane Rita affected the area directly. With winds reaching 180 mph, the SPF roof held firm.

Because Fort Polk is located in Louisiana, the now-obvious question is how any building might stand up against severe weather. While Hurricane Katrina was not a factor for the Fort Polk Base due to its location being out of that storm's path, Hurricane Rita affected the area directly. With winds reaching 180 mph, the SPF roof held firm.

It is not surprising that the Bayne-Jones Army Community Hospital was able to stand up against Hurricane Rita. SPF roofing systems are seamless and self-flashing, making wind uplift virtually impossible. The roof's monolithic construction does not allow for any edges that wind would otherwise get under and lift. Wind uplift resistance is a significant feature for any roof, as roof failures are the leading cause of building loss during extreme weather events. Once a building loses one or more pieces of roof deck, the losses increase exponentially due to the vast amount of water that enters the building. With SPF roofs, pieces do not fly off because the roof is literally one piece. Furthermore, the closed-cell foam does not allow water to migrate through the material, leaving the roof system leak-free after a storm.

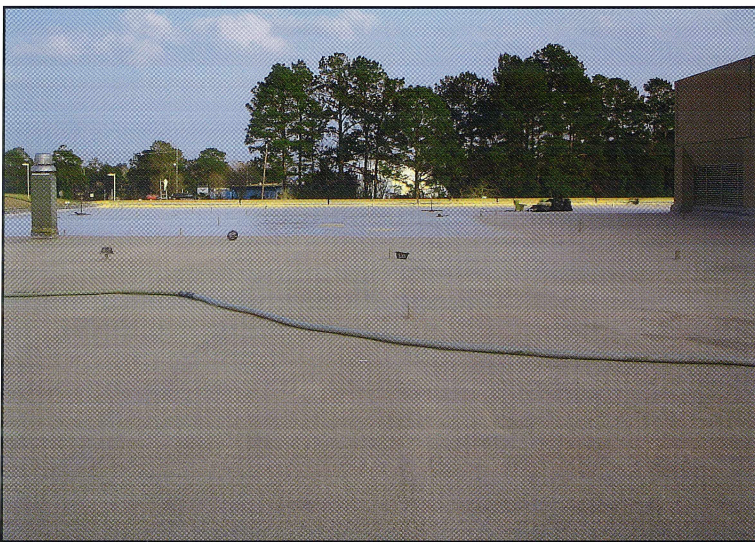
"The new SPF roofing did its job just like it should," says Sean Stumler. "It didn't budge an inch or leak a drop. We went down and inspected the roof after Hurricane Rita and there was no wind damage at all. It performed perfectly."

"The new SPF roofing did its job just like it should," says Stumler. "It didn't budge an inch or leak a drop. We went down and inspected the roof after Hurricane Rita and there was no wind damage at all. It performed perfectly."

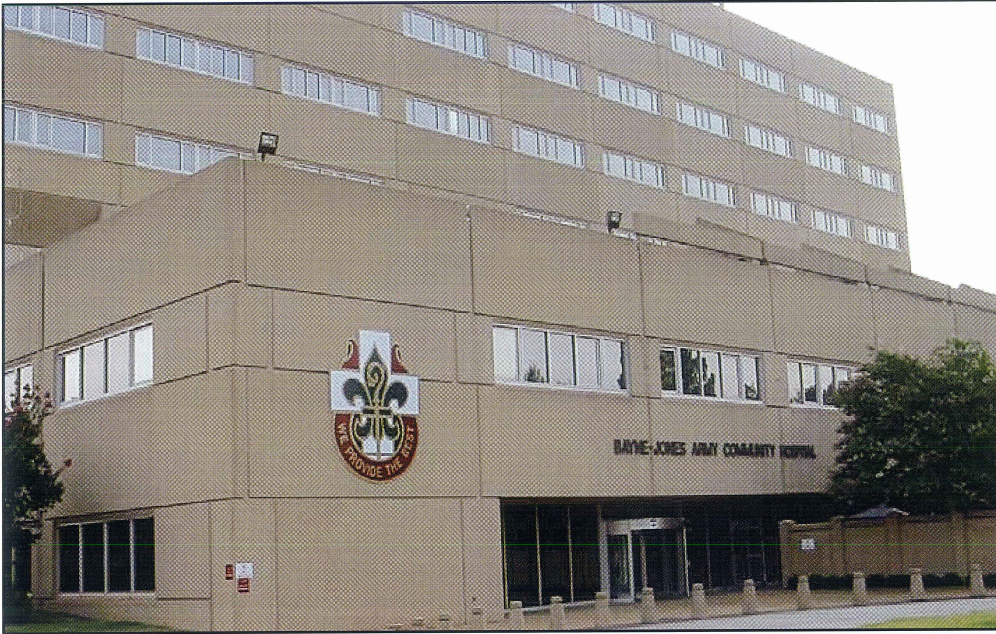
The Bayne-Jones Army Community Hospital re-roofing project presented some serious challenges for the renovation team.

The Bayne-Jones Army Community Hospital re-roofing project presented some serious challenges for the renovation team. The facility is very active, so disruption to the function of the hospital had to be minimal. The 125,000 square-foot roof, made up of built-up roofing (BUR) over concrete, had many fresh air intakes that had to be protected from the fumes and odors associated with a construction project. The most challenging aspect? The existing roof had sections covered with 3' x 12' concrete footings that supported damaged and unusable solar collection units. It was determined that these units would have to be removed and the spaces they left filled in.

Stumler says the SPF roofing was an ideal choice for the Bayne-Jones Army Community Hospital, because of its quick and low-disruption application methods. In addition, as a spray-applied system, SPF makes it easy to cover an uneven roof surface—like that left by the removed concrete footings—smoothly and seamlessly.

"We applied an inch and a half of SPF," explains Stumler. When asked if the building's function as a hospital provided an extra challenge, he says, "The minimal disruption of an SPF application was key in keeping the facility functioning normally. A different system may have required the BUR and concrete roofing to be removed, which would have caused significant disruption."
