## OVERCOMING YEARS OF NEGLECT

*Atlanta, GA*

### ATLANTA FARMERS MARKET

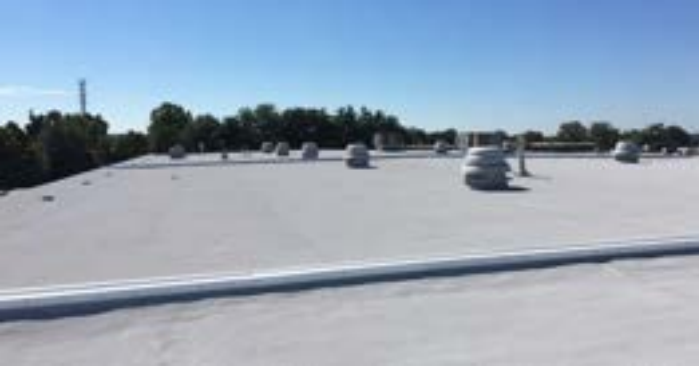
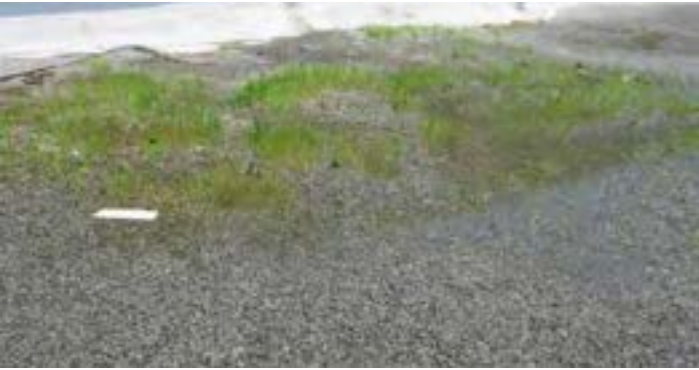
*After being ignored for 22 years, this roof was in pretty bad shape when we arrived.*

The Market's 103,000 square foot roof consisted of spray foam covered in loose gravel and was installed in 1992. During the 22 year life of the roof, not one day's worth of maintenance work had ever been completed. The result of this neglect was a roof with many leaks that created an unsafe work environment and damaged goods. Although spray foam roofs can last more than 40 years, annual inspections and minor maintenance are required to maintain a leak-free roof. The Farmers Market desperately needed a new roof, but the installation was difficult to coordinate around its operating schedule: open 24 hours a day, 7 days a week. This meant that whatever roofing solution was chosen had to be non-invasive and installed quickly.

- Removed the gravel with a wet vacuum.
- Scarified the entire roof surface to remove damaged foam.
- Applied new spray foam to the roof.
- Applied a protective layer of silicone coating to the foam.

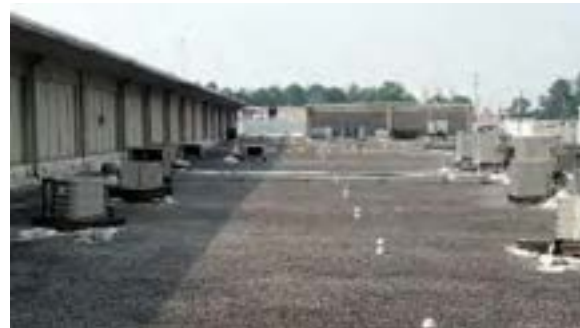
The new SPF roofing system provides a longer lasting roof system versus the older foam and gravel system. The new sustainable roof is leak free and completely renewable in 15 years by simply applying a new silicone coating. The new system also provided the following benefits:
